Manhole Inspection Summary

Manhole # S19GG_002MH

Insp Date: **6/14/07 9:30 AM**

Location Address: **1519 APPLETON-MONROE**

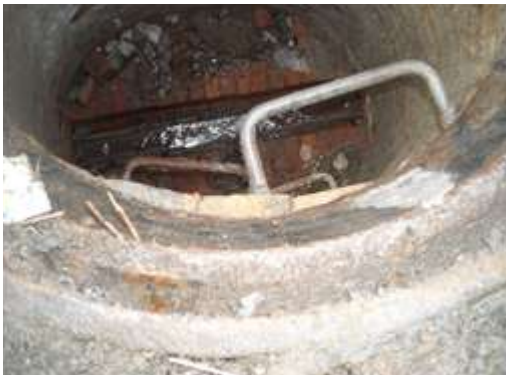
Defect 3

Frame Offset: **1** (in.) Condition: ☒ Sound ☐ Cracked ☐ Leaks

FRAME OFFSET 1"

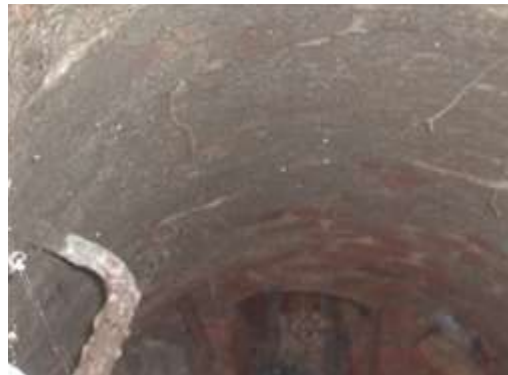
Defect 3

Condition: ☐ Sound ☐ Cracked ☒ **Root Intrusion** ☐ Loose Brick ☐ Deteriorated

ROOT INTRUSION ON CORBEL

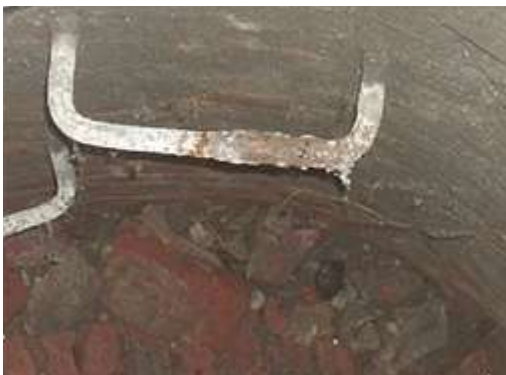
Defect 1

Steps Count: **2** Missing: **0** ☒ **Corroded**

CORRODED STEP

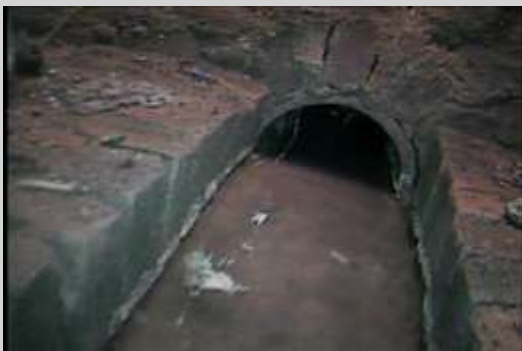
6 O'Clock Inflow

Pipe Height: **7.2** (in.) Rod and Bar (Angled)
Pipe Material: **Clay** ☐ Pipe Lined
Invert Depth: **7.39** (ft.) Flow Characteristics: **Slow**
Deposits: ☐ None ☐ Mud ☐ Sludge ☒ **Debris** ☐ Grease
Silt Depth: **2** (in.) Deposits Extent: **Light**
Infiltration: **None** Pipe Seal Cond: **Sound**
